Manhole Inspection Summary

Manhole # S05AA2023MH

Insp Date: **8/17/06 12:00 AM**

Location Address: **5925 BLAND AVE**

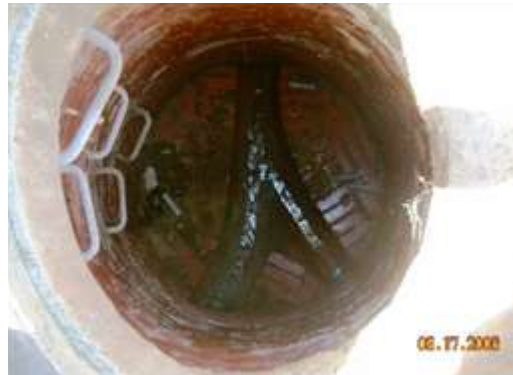
Top View

Frame leaks. Adjustment and Barrel infiltration. Evidence of surcharge - Bench debris.

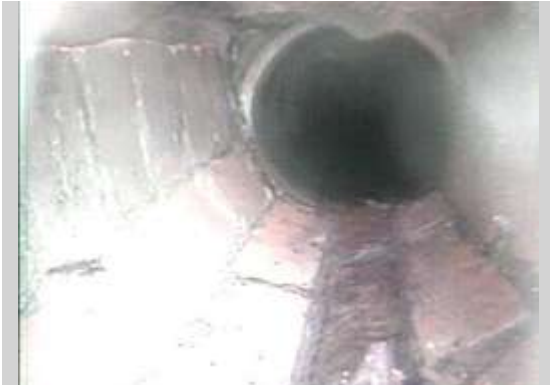
8 in. Circular Gravity Sewer Pipe Out @ 12 O'Clock

Infiltration: **Evidence** Pipe Seal Cond: **Cracked**

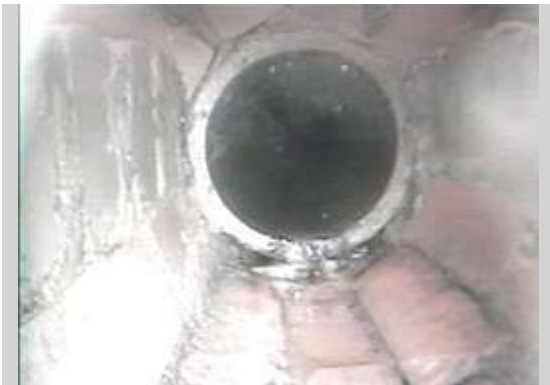
6 in. Circular Gravity Sewer Pipe In @ 4 O'Clock

Infiltration: **Evidence** Pipe Seal Cond: **Cracked**

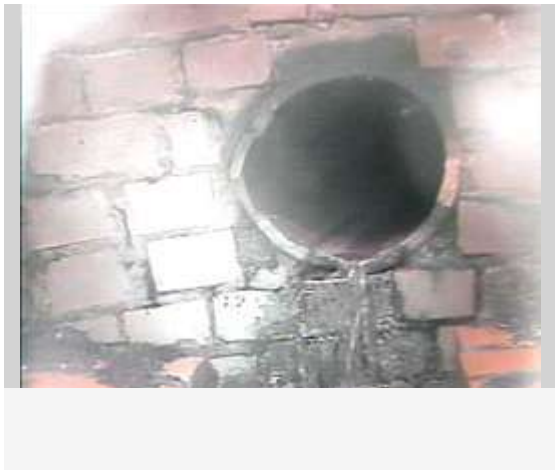
8 in. Circular Gravity Sewer
Pipe In @ 7 O'Clock

Infiltration: **Evidence** Pipe Seal Cond: **Broken**
